ON-SITE AMBULANCE CRASH INVESTIGATION

CASE NUMBER - IN10032
LOCATION - WEST VIRGINIA
VEHICLE - 2003 FORD E350 TYPE II AMBULANCE
CRASH DATE - September 2010

March 7, 2011

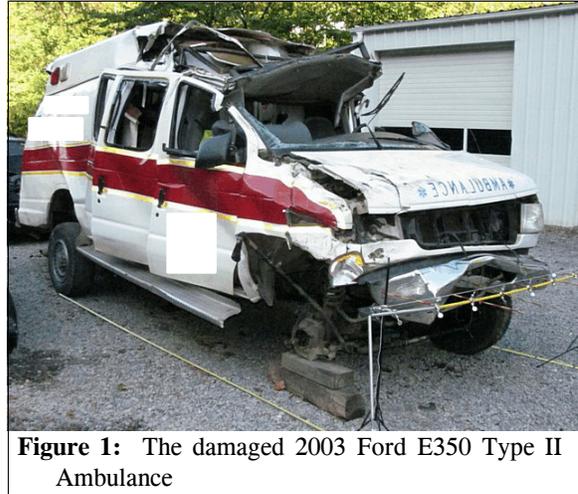
This on-site investigation focused on the dynamics of the crash and the injury sources for the fatally injured driver of a 2003 Ford E350 Type II Ambulance (**Figure 1**). This crash was initiated by the National Highway Traffic Safety Administration (NHTSA) on September 8, 2010 through an on-line news article. This investigation was assigned on September 10, 2010. The crash occurred when the ambulance impacted a guard rail and rolled over. The crash happened in September, 2010, at 0300 hours, in West Virginia and was investigated by the county sheriff department. The ambulance and the crash scene were inspected on September 13-14, 2010. An interview was conducted with the chief of operations for the ambulance service and the Emergency Medical Technician (EMT) on September 20, 2010. A passenger of the ambulance (the mother of the patient) was interviewed on September 16, 2010. This report is based on the police crash report, ambulance inspection, crash scene inspection, exemplar vehicle inspection, interview information, occupant kinematic principles, and evaluation of the evidence.
